OUTLINE REPORT OF
ARCHITECTURAL WORK
ON THE RESTORATION OF THE
CHESAPEAKE AND OHIO CANAL
FOR RECREATIONAL USE
(GEORGETOWN, D. C., TO SENECA, MD)

BRANCH OF PLANS AND DESIGN
Thos. C. Vint
Chief of Planning

1939

Dallas D. L. McGrew
Associate Architect

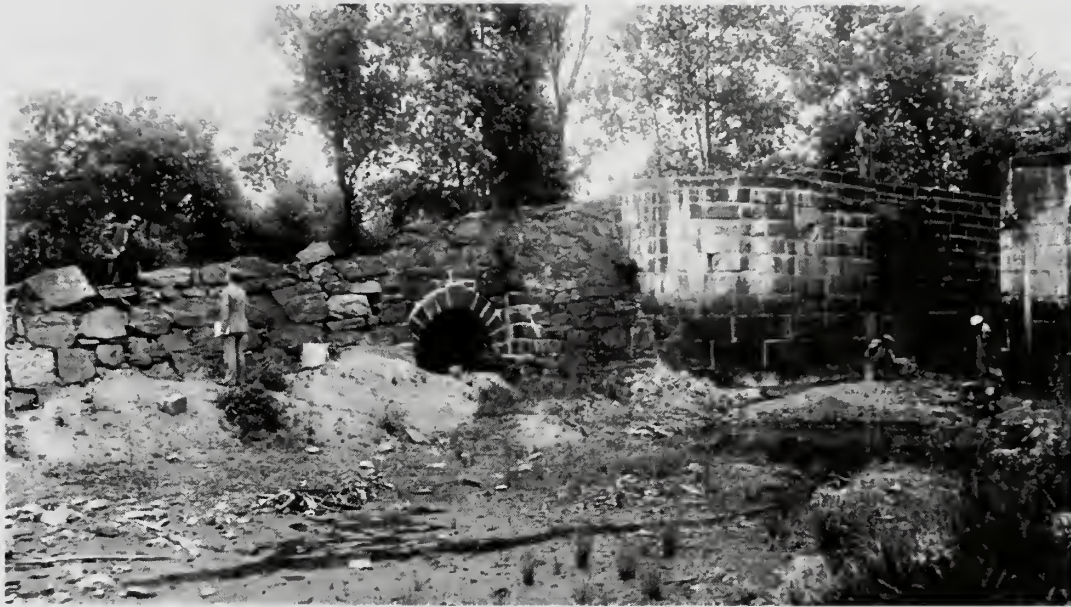
Photograph 14: Spillway culvert, south end of Lock No. 18, carrying excess water under the towpath to the River. This masonry has been repointed.

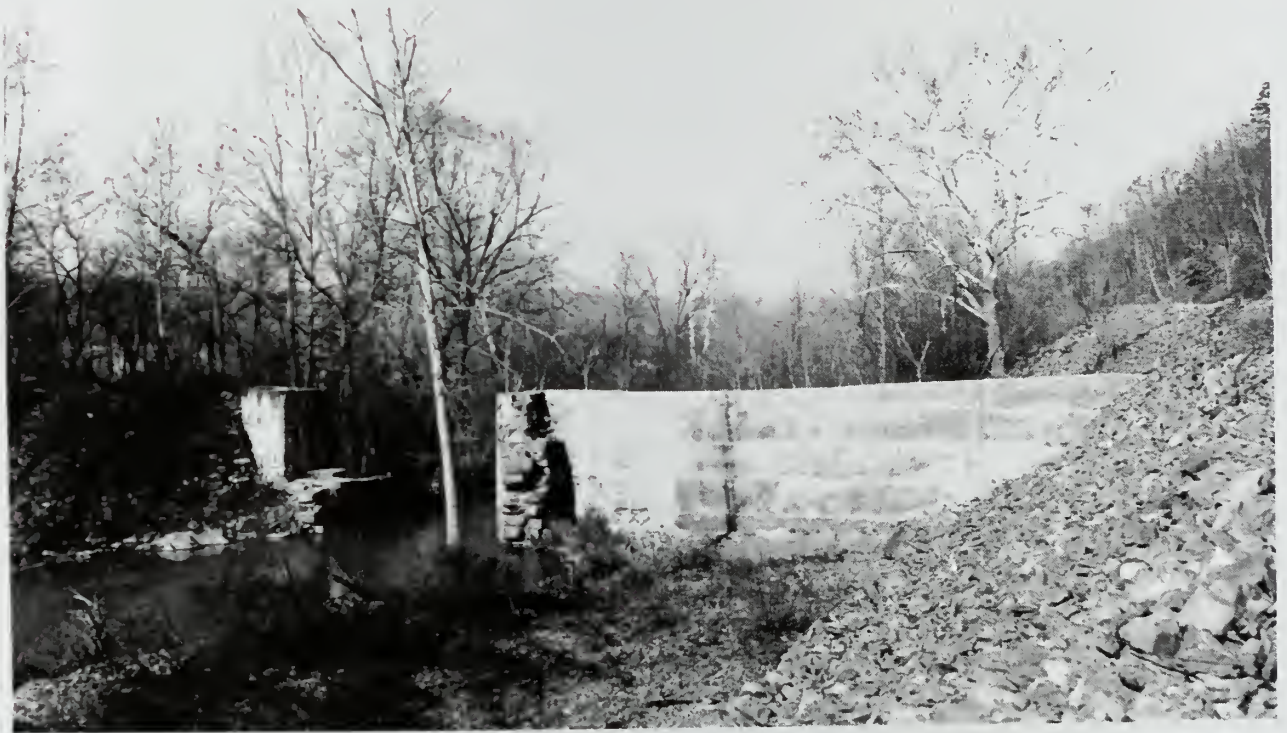
STOP LOCK: Of this structure only the abutments, one considerably damaged, survive. The dam also was washed out in places – especially at the bermside end. A concrete core wall has been built, covering the old masonry core, and considerable work is required here to put the structure in useful condition. The building that sheltered the operation of this Stop Lock was long since washed away and no record of it has been discovered. At Dam No. 4, below Williamsport, Maryland, however, there is a structure serving a similar purpose, and this has been studied to provide a knowledge of its operation. On the basis of this evidence a building of the same structural system and architectural character, logically adapted to the different conditions of the site, has been designed for the Stop Lock at Lock No. 16. In this building it is planned to install the original hoisting machinery from Dam No. 4, the later being outside the present program. Thus the old equipment will be both preserved and also used in a practical demonstration of considerable historical interest. The building is to be covered with well weathered siding taken from another Canal building, of no particular significance, and will therefore start with an appearance of mellow age.

Photograph 20: Stop Lock above Lock No. 16, showing the abutments and the new concrete core wall covering the old masonry core at the Berm, or east end.

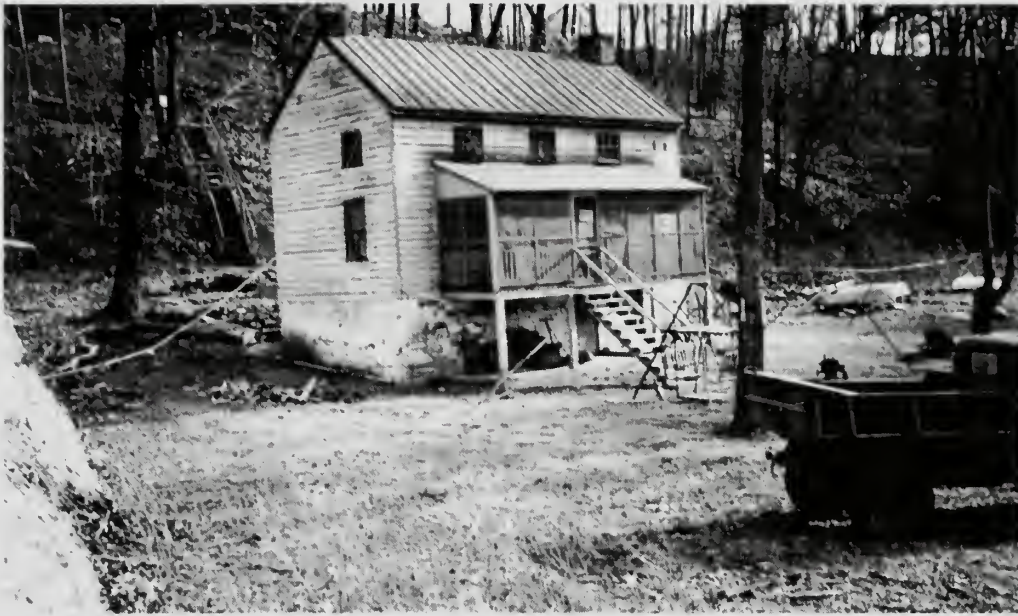
Photograph 24: The house at Lock No. 5, a frame building on masonry walls. This is being restored for use, with the addition of dormers for added light and ventilation, and of plumbing.

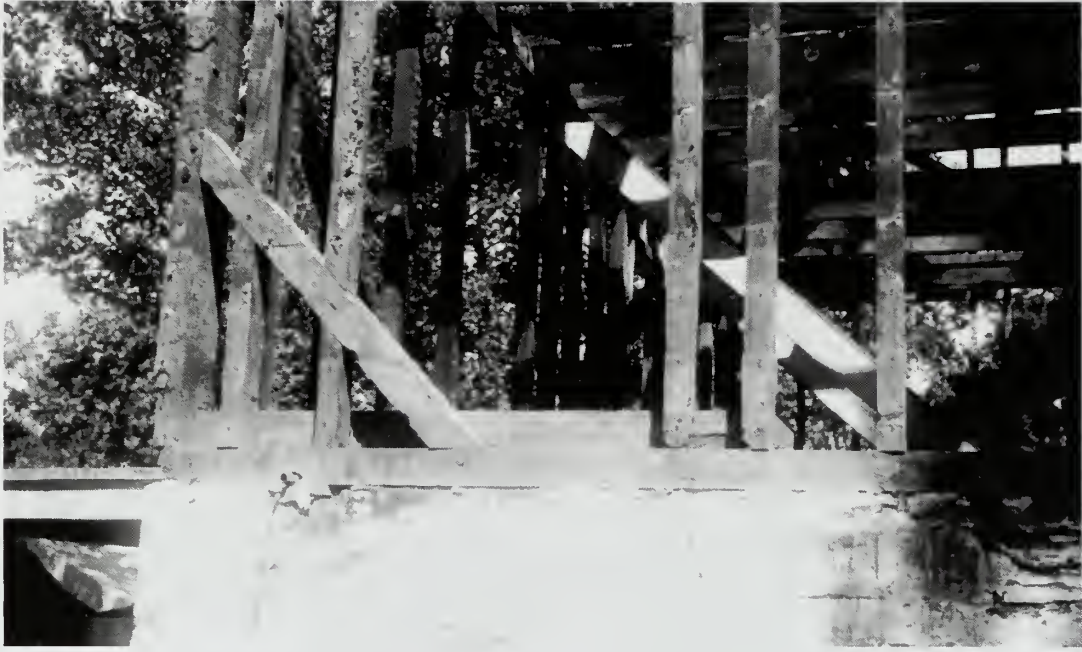
Photograph 26: The framing of the house at Lock No. 5. The diagonal braces were mortised and pegged into both the posts and the sills. Note that rats have gnawed away the studding just above the sill.

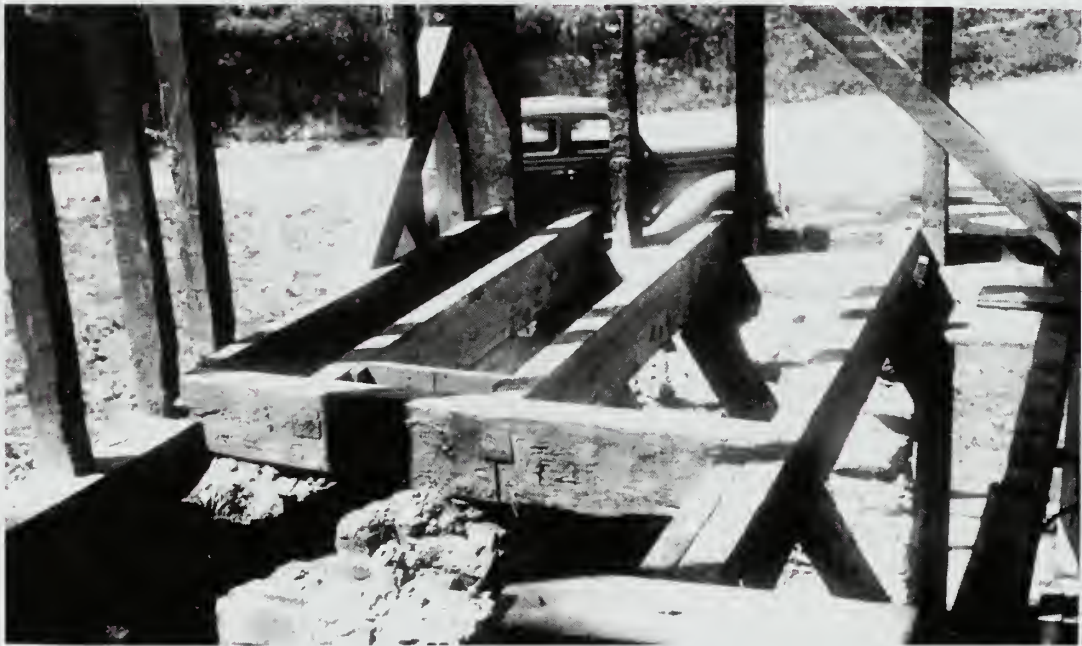
Photograph 27: Another view of the old framing; the header at the hearth, showing tail joints mortised and pegged. This framing is found to be generally in sound condition although it has stood since 1853, when this house was rebuilt. With very little repair it is serving now.

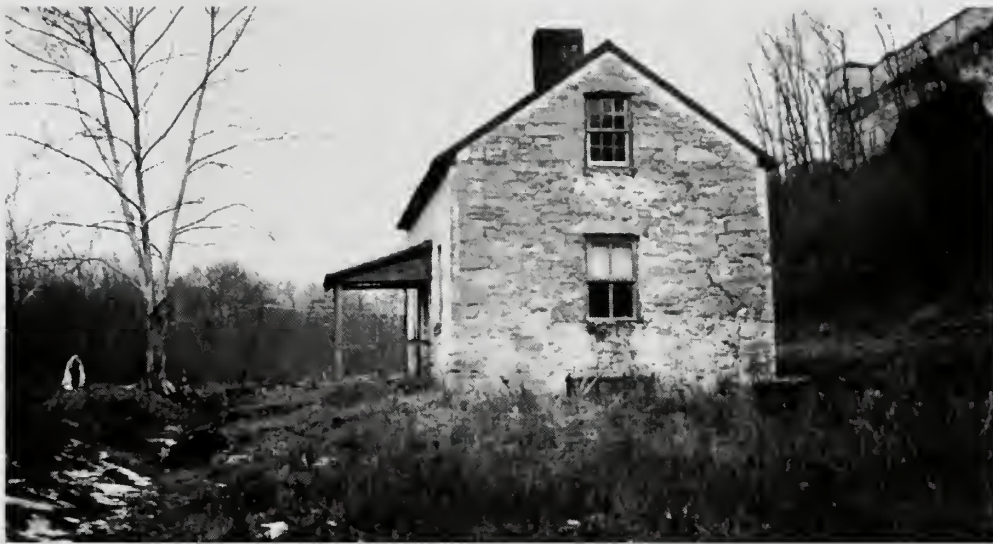
The house at Lock No. 7 is the first of the stone houses selected for rebuilding under the restoration program. Floods had damaged the masonry so badly that one corner had collapsed. It had been relaid sometime in the past, but so badly that it had to be taken down again and rebuilt properly to insure future stability. The building presents no unusual features. The design for restoring it introduces dormers and modern facilities as in the house at Lock No. 5. Built by the contractor James O'Brien, this was the first house to be completed on the Canal (August 1829). In excavating the basement, it became evident that Mr. O'Brien ignored the masonry specifications, and it was necessary to strengthen the structure.

Photograph 29: House at Lock No. 7. Settlement cracks in the wall, carelessly rebuilt after the 1936 flood tore away some of it. This had to be taken down and relaid before the work of restoration for use could be carried out. Here again dormer windows and plumbing were added and the interior rearranged for greater economy and comfort.

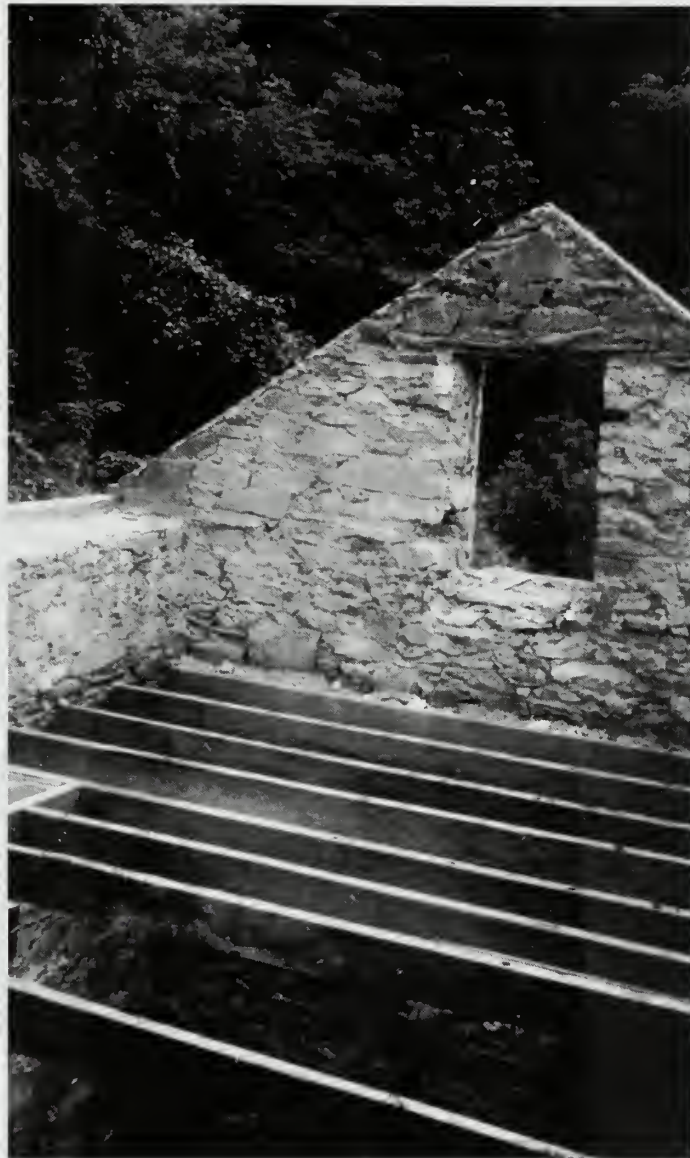
Photograph 30: The masonry of house at Lock No. 7. This shows the plate resting on the stone wall without the wooden grounds called for by the specifications; also the joists are built into the masonry.

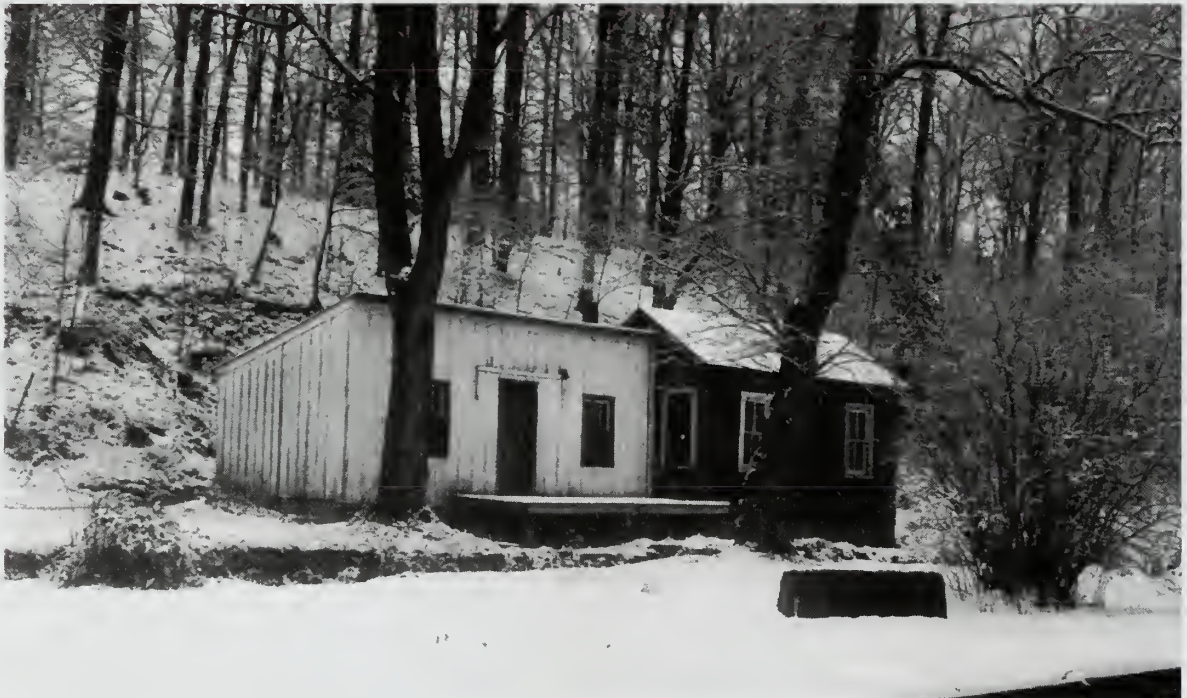
The building at Lock No. 9 is a light wooden structure erected on stone foundations. There is no record of its history, and it seems to be of comparatively recent date, with an even later addition. It is hardly usable without repairs.

Photograph 32: House at Lock No. 9. This building is a piece-meal structure of uncertain date, hardly usable in its present state, except for the new, shingled addition.

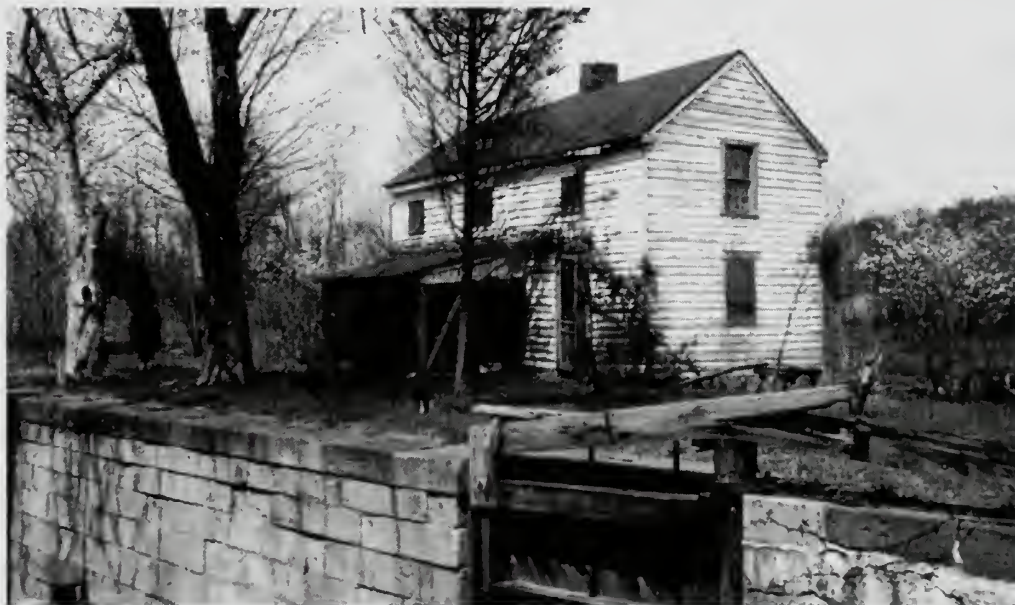
The house at Lock No. 12 is a departure from type, being a frame building on shallow stone foundations, and a little larger than the earlier houses. It is in poor condition and, if ever needed in the operation of the Canal, it will have to be entirely rebuilt.

Photograph 36: House at Lock No. 12. A frame building differing from the established type. There are only shallow foundations, no cellar. If the building is to be used it virtually will have to be rebuilt. The lock wall appears in foreground.

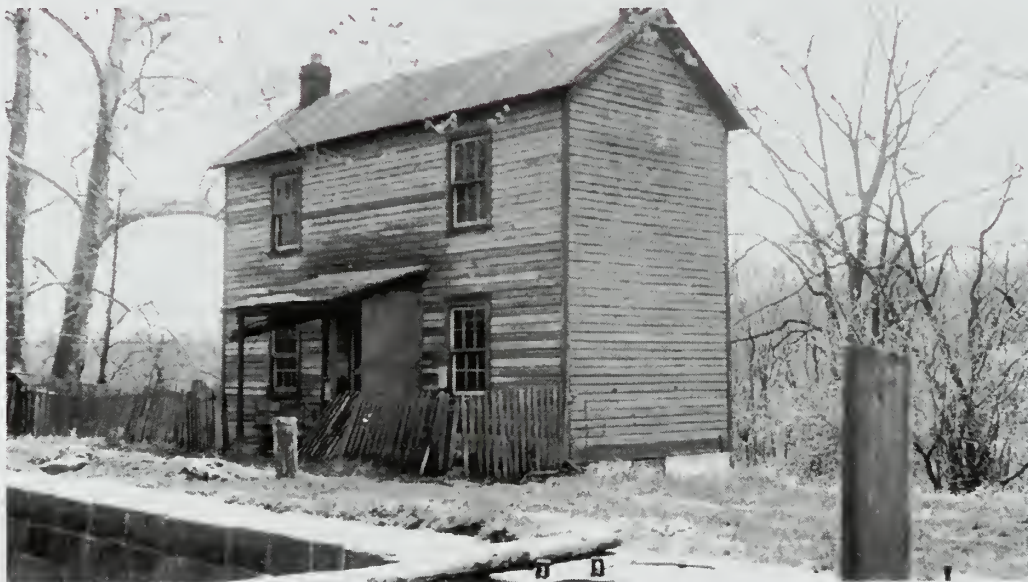
Another typical house is at Lock No. 14. On characteristic stone foundations with concrete additions of later date the frame building is hardly in condition for use, but no work is contemplated on it.

Photograph 38: House at Lock No. 14. A departure from type. Frame structure on the towpath side. Substantial repairs will be needed here if this house is to be used.

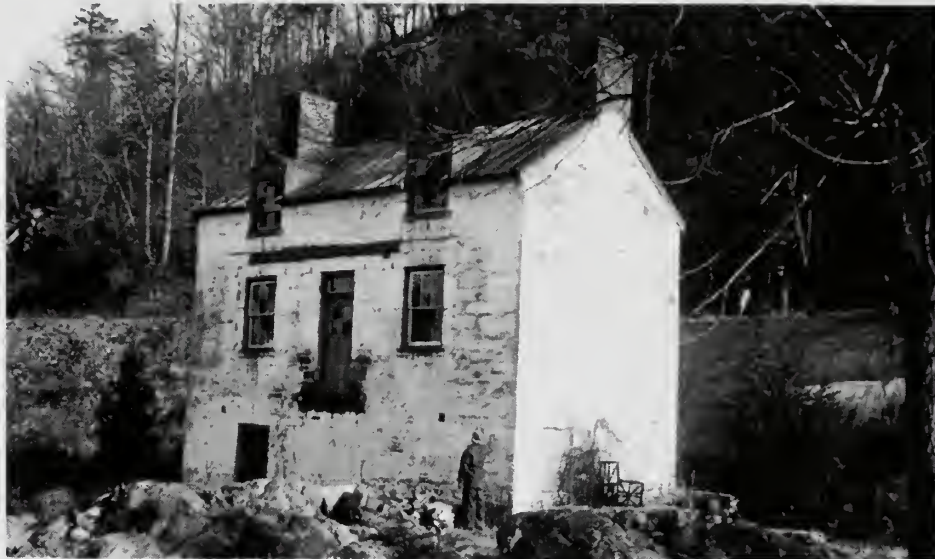
On a rocky ledge overhanging Lock No. 16 is a stone house having two stories and an attic with dormers, and a chimney at each end. This was built from a second specification, adopted in 1836. The building is in sound condition, being out of reach of all but the highest floods, but considerable work would be required to render it habitable.

Photograph 39: House at Lock No. 16. The first house built from the second or 1836 specifications. It stands on a rock ledge well above the lock. This building cannot be used without considerable reconstruction of the interior.

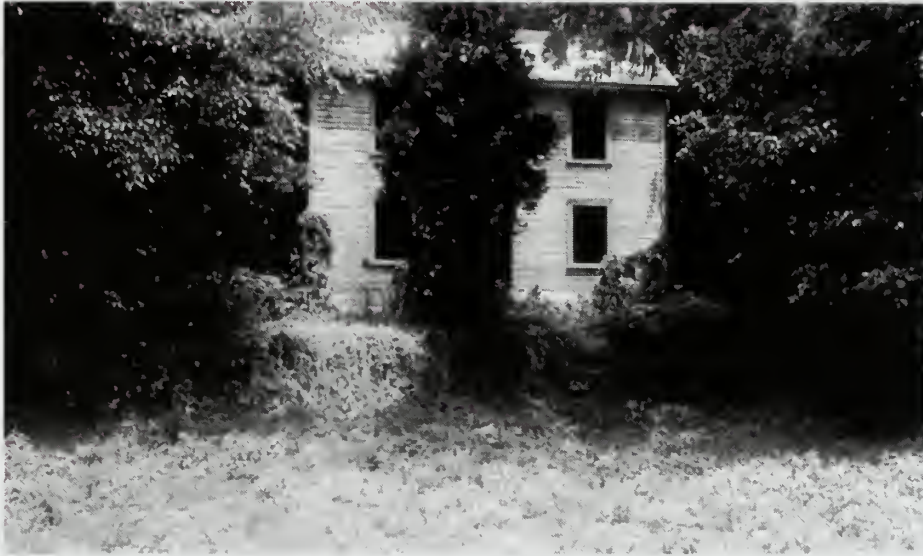
Photograph 41: Frame house at Lock No. 17. In dilapidated state and of unknown date.

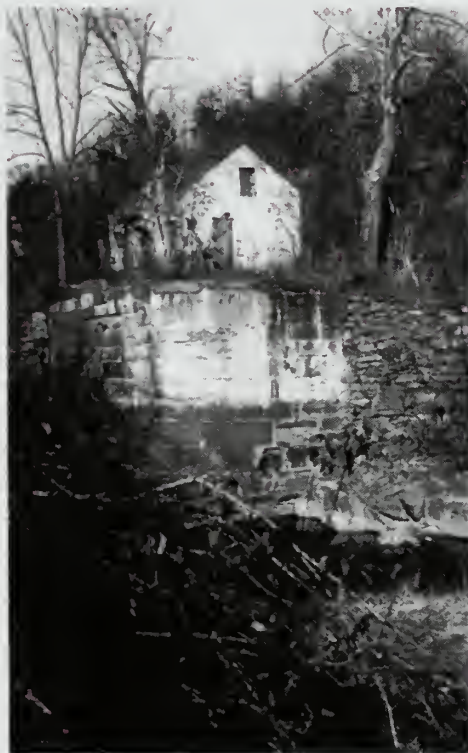
The walls of another stone house stand at Lock No. 18. This structure was gutted by fire not many years ago, but the standing masonry walls are a picturesque ruin, and will be preserved in this condition.

Photograph 42: House at Lock 18. Gutted by fire; will be kept in this condition. Lower end of the lock walls in foreground.

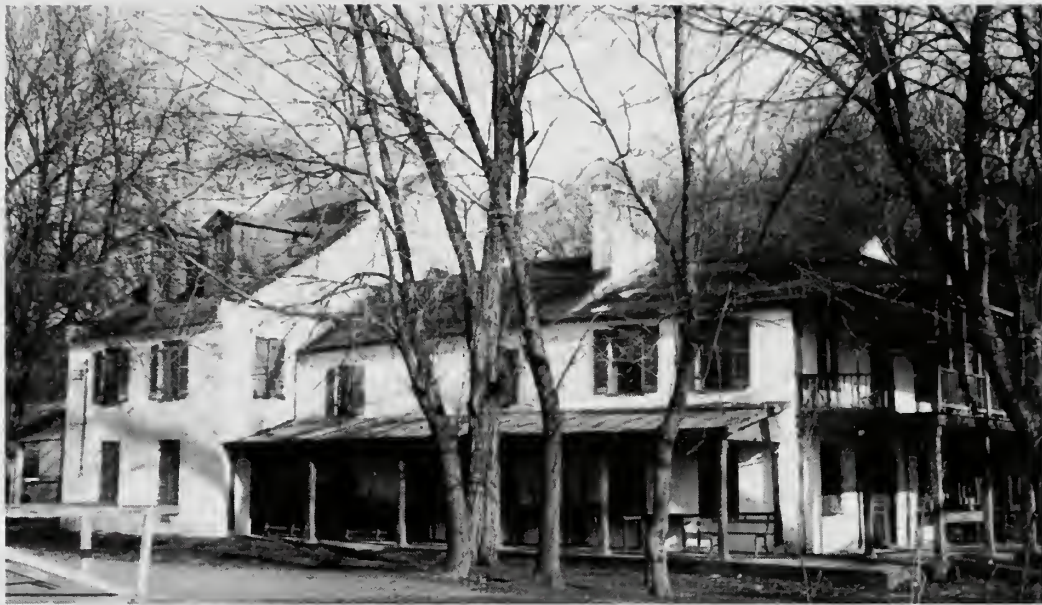
Photograph 45: Tavern from the southwest. Part of this brick addition of 1832 is in bad condition and repairs are to be made. This tavern has served its purpose almost continuously for more than a century, operated by the members of one family since the Civil War.

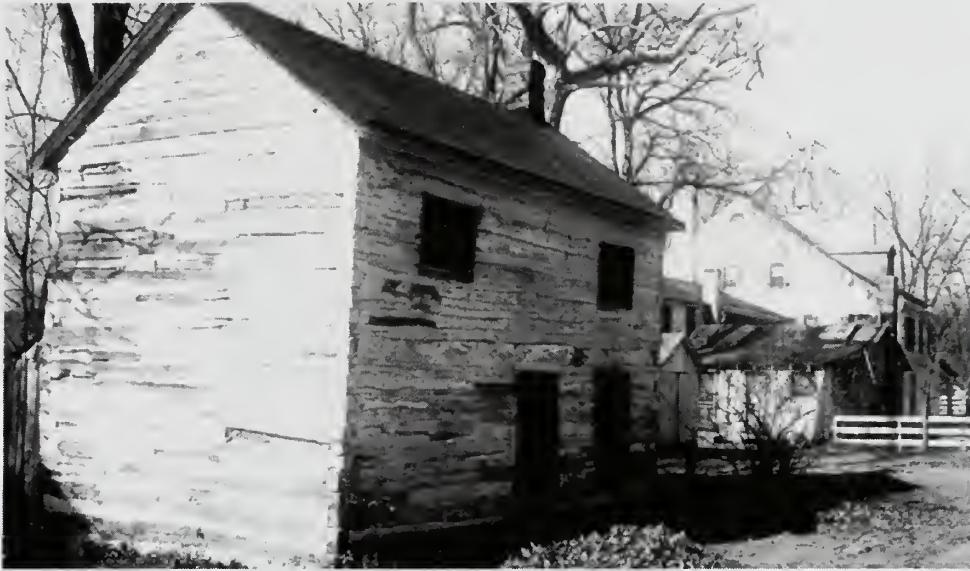
Near the Tavern stands a log house built about 1884 and used since as a tender's dwelling. This small building is being put into good condition and will continue to serve its original purpose. It is interesting to note that the occupant of the log structure considers it most comfortable, as the thick logs keep it cool in summer and warm in winter.

Photograph 47: The Log House south of Tavern, built of hewn logs about 1884. This is to be repaired for use as a Lock Tender's House. It is described by those who live in it as particularly cool in summer and warm in winter.

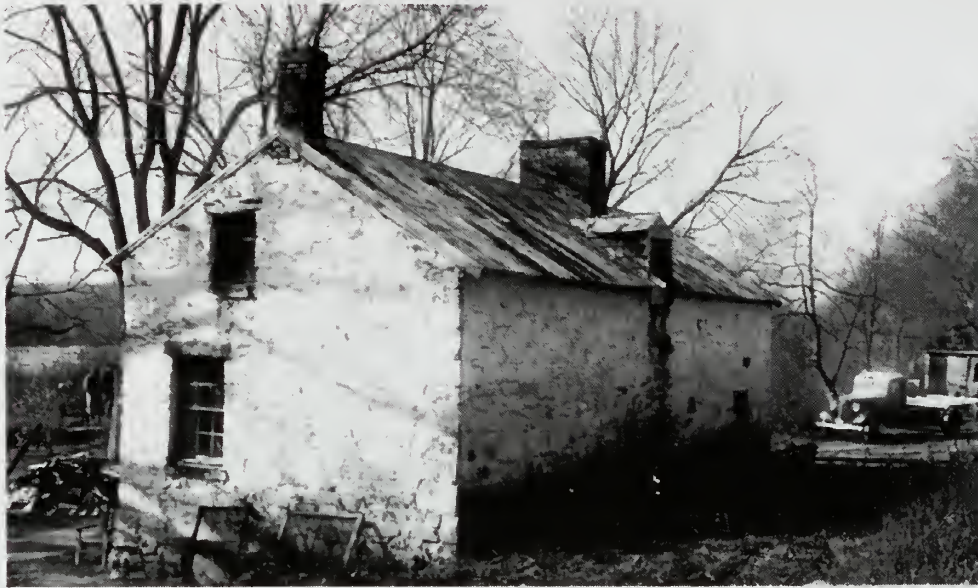
Above Great Falls, after a stretch of several miles, is Lock No. 21 or Swain's Lock, with a stone house of still another type. This is in usable condition but needs repairs.

Photograph 51: House at Swain's Lock (No. 21). This building varies from the established type. Its relationship to the lock can be judged from the lock curbing in the left foreground. The structure is in fair condition and continues in use.
